### MONTEREY PENINSULA REGIONAL PARK DISTRICT BOARD REPORT

**DATE:** October 7, 2026  
**TO:** Board of Directors  
**FROM:** Jake Smith, Planning & Conservation Program Manager  
**REVIEWED BY:** Eric Morgan, General Manager *E. S. Morgan*  
**SUBJECT:** Rancho Cañada Floodplain Restoration Project Monthly Progress Report

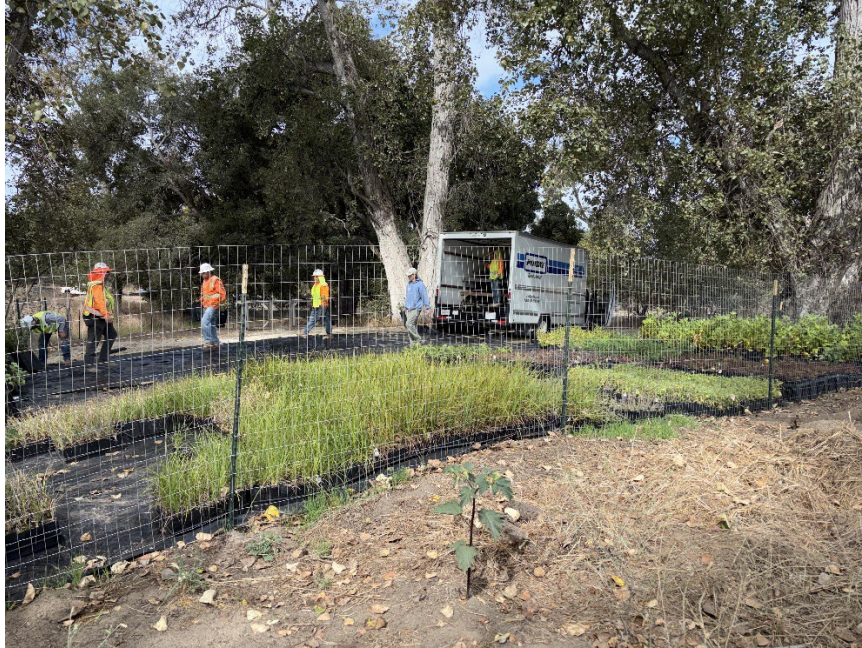
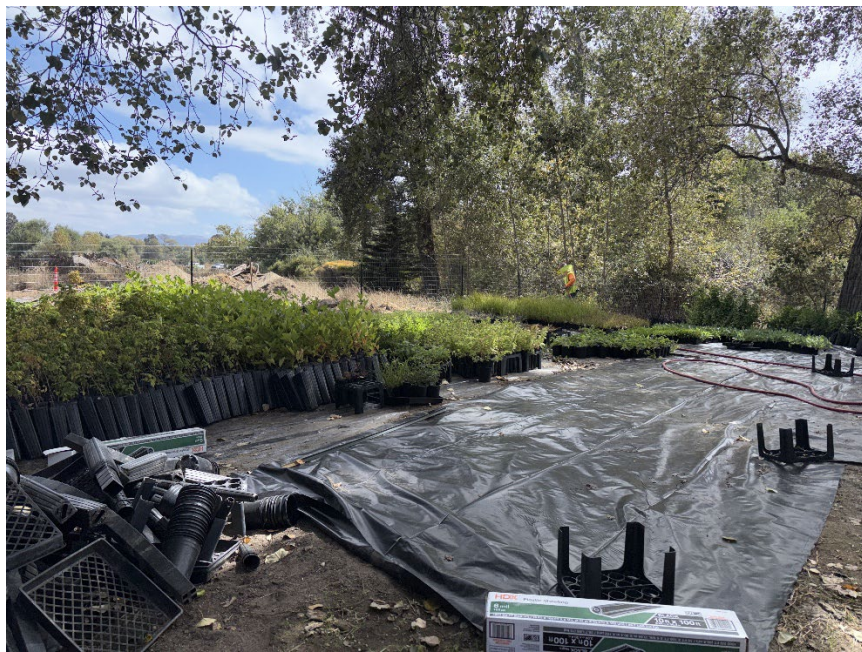
**Photos 2 & 3: Thousands of native plants being delivered by MPRPD's plant propagation contractor to the temporary on-site plant nursery while they await installation.**

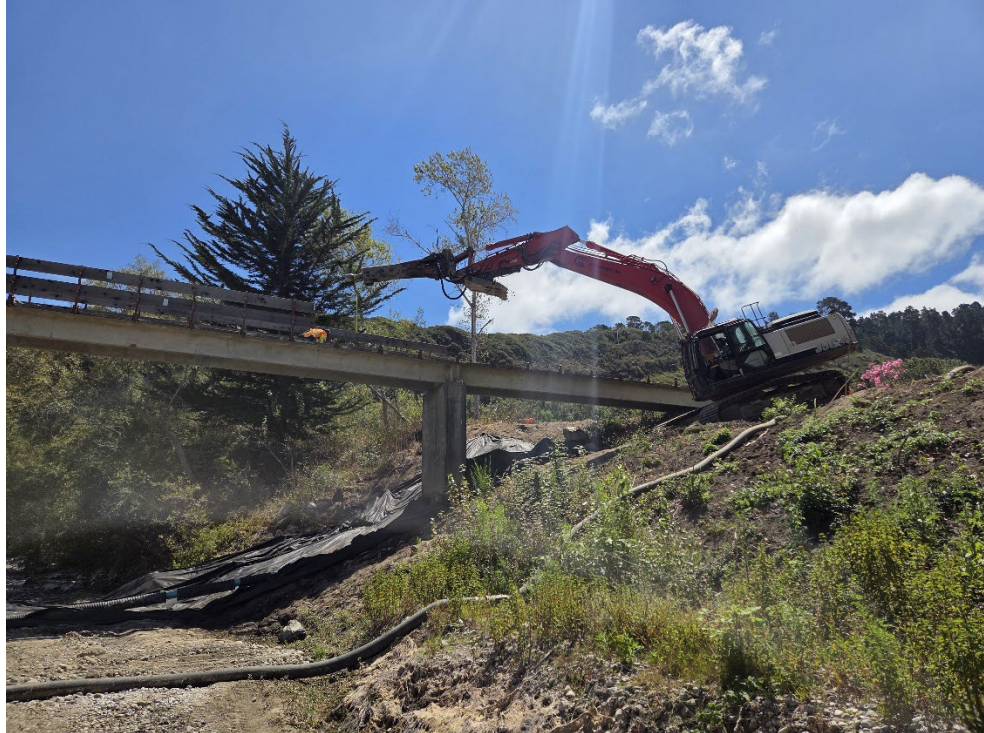
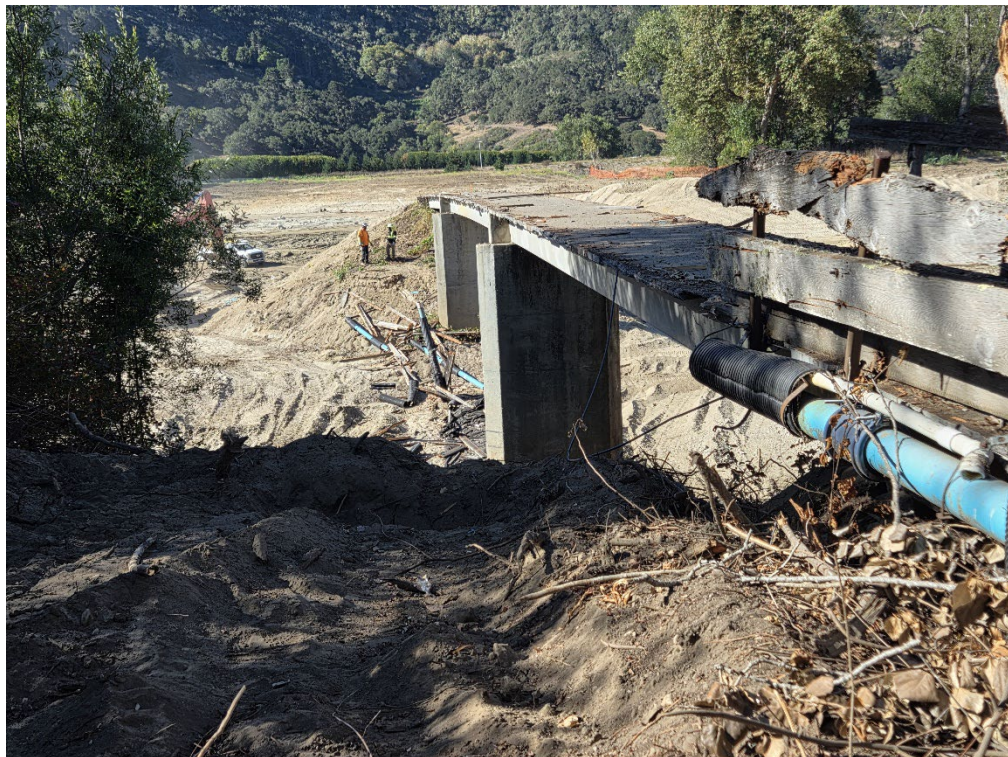
**Photos 4 & 5: Demolition of Bridge #2 over the mainstem of the Carmel River.**

- Both former golf course bridges were removed. Bridge 1 was removed in late August and Bridge 2 in early September. Before each removal, crews dried out the work area and safely relocated wildlife. The rock that had been placed around the old bridges to protect them from erosion was saved and reused elsewhere in the project area.

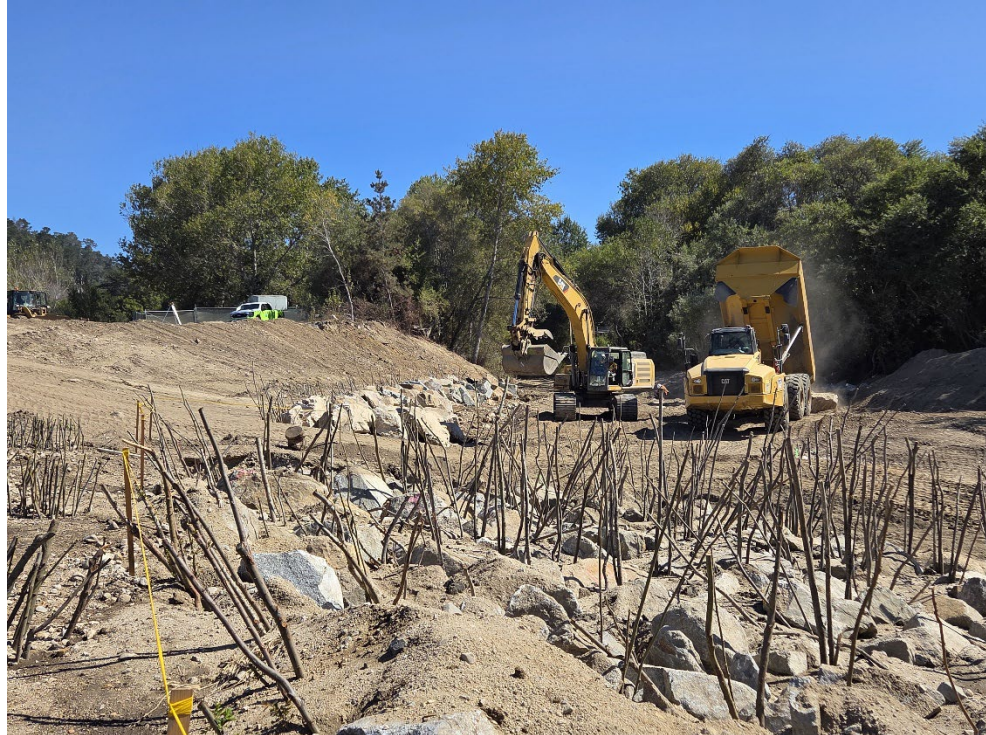
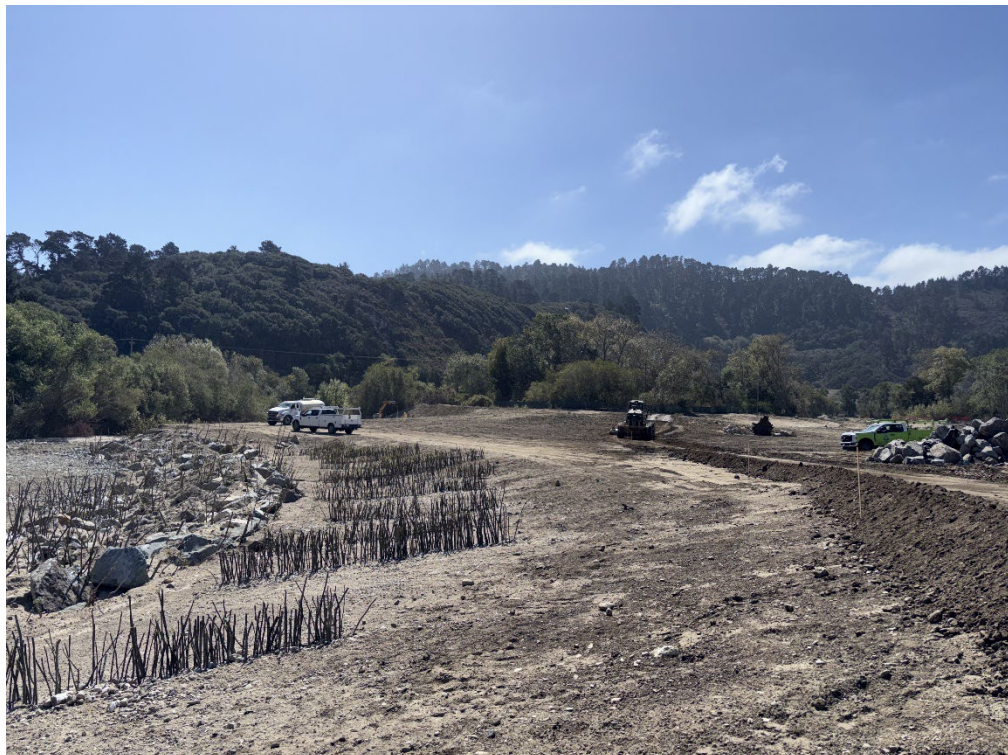
**Photos 6 & 7: Installation of the IC channel widening, bank armoring, and willow pole cuttings.**

- Work continued in the easternmost channel area, known as IC-6, where crews shaped the channel, set boulders, placed soil and gravel, and installed the salvaged rock along the bank. Bank protection work in this area was paused in mid-September while the design was revised, as described under Construction Contract Status below.

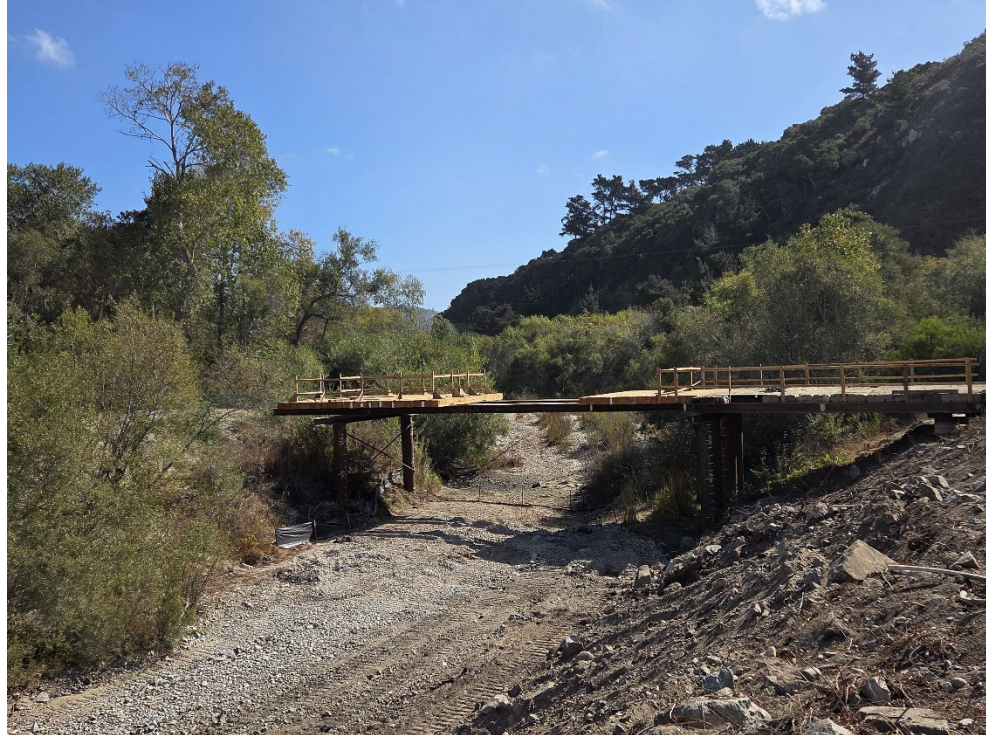
**Photos 8. Looking upstream at a temporary structure to support installation of the new bridge.**

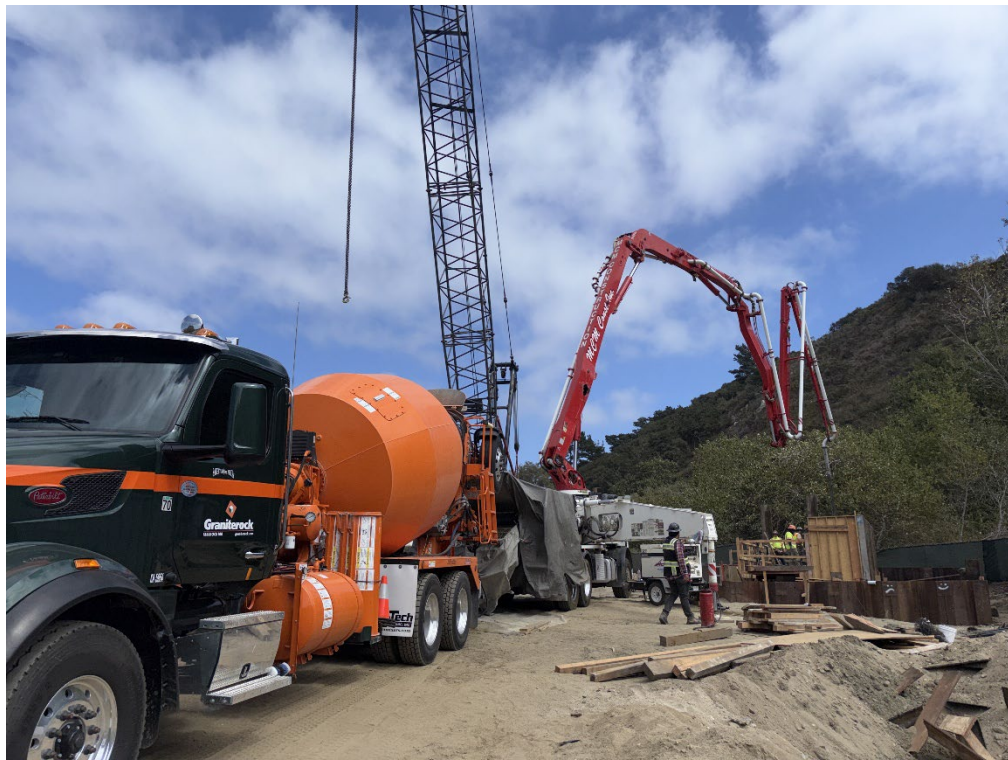
**Photos 9. Concrete truck pouring the final concrete lift of the bridge abutment.**

- Concrete work on the two supports for the new pedestrian bridge neared completion on both riverbanks, including the foundations, walls, and side walls, with independent testing of the compacted soil behind them.

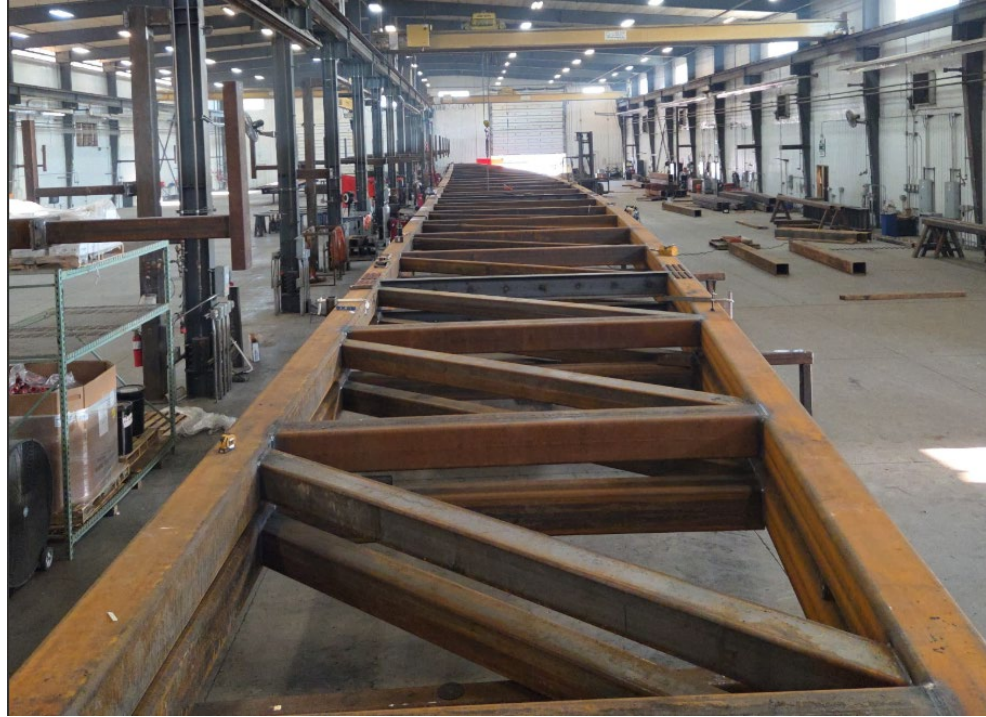
**Photo 10. Fabrication of the new 265-foot-long clear span steel truss bridge in Loveland, Colorado.**

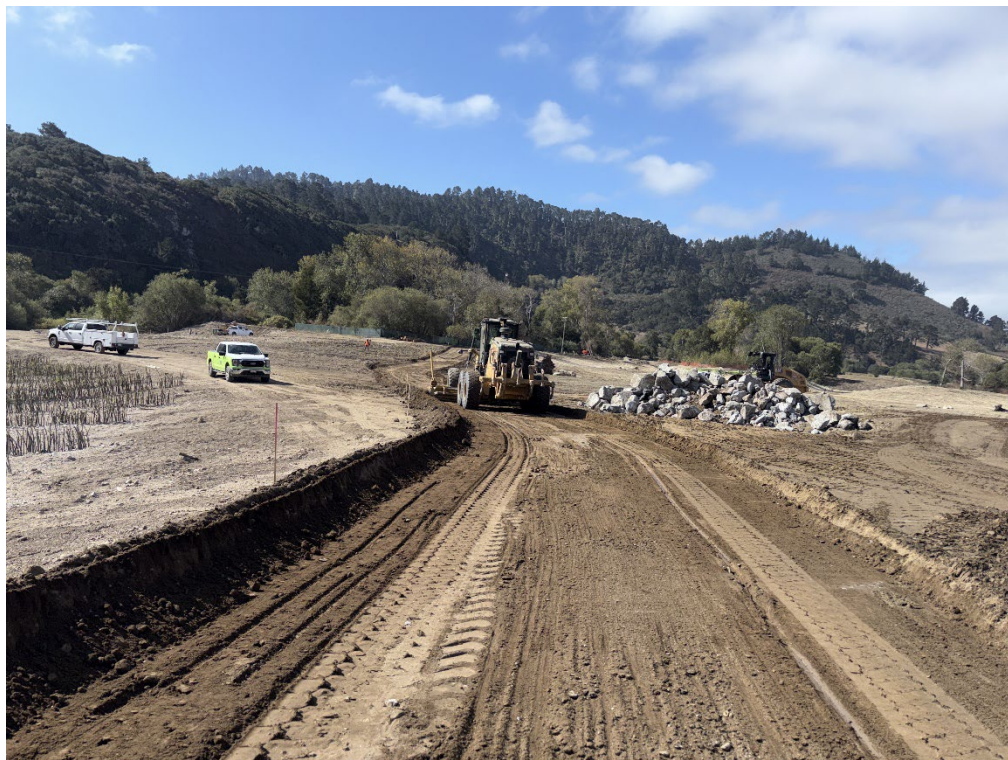
**Photo 11: Rough grading of a new operations access road and public trail connection across the lowered floodplain.**

- New aggregate access road was installed to replace an access road that was removed, connecting the Santa Lucia Conservancy headquarters and outdoor education area to MPRPD's headquarters parking lot.

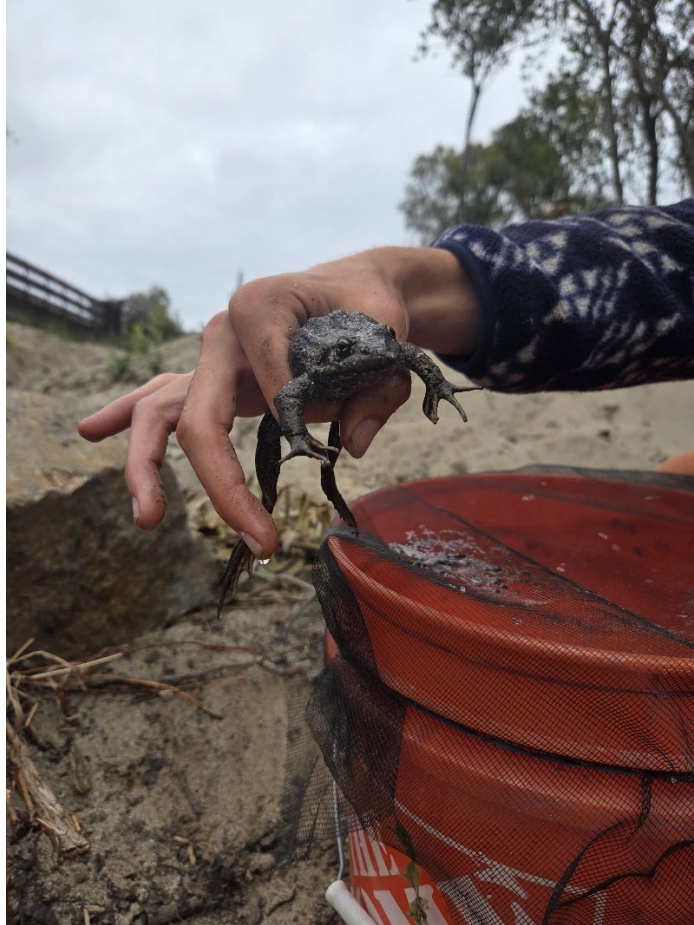
**Photo 12: California red-legged frog captured and relocated away from the bridge demolition area.**
